# **FINAL REPORT REMEDIAL INVESTIGATION**

## **FORMER ASPHALT PLANT**

### **CAMP NAVAJO BELLEMONT, ARIZONA**

July 1999

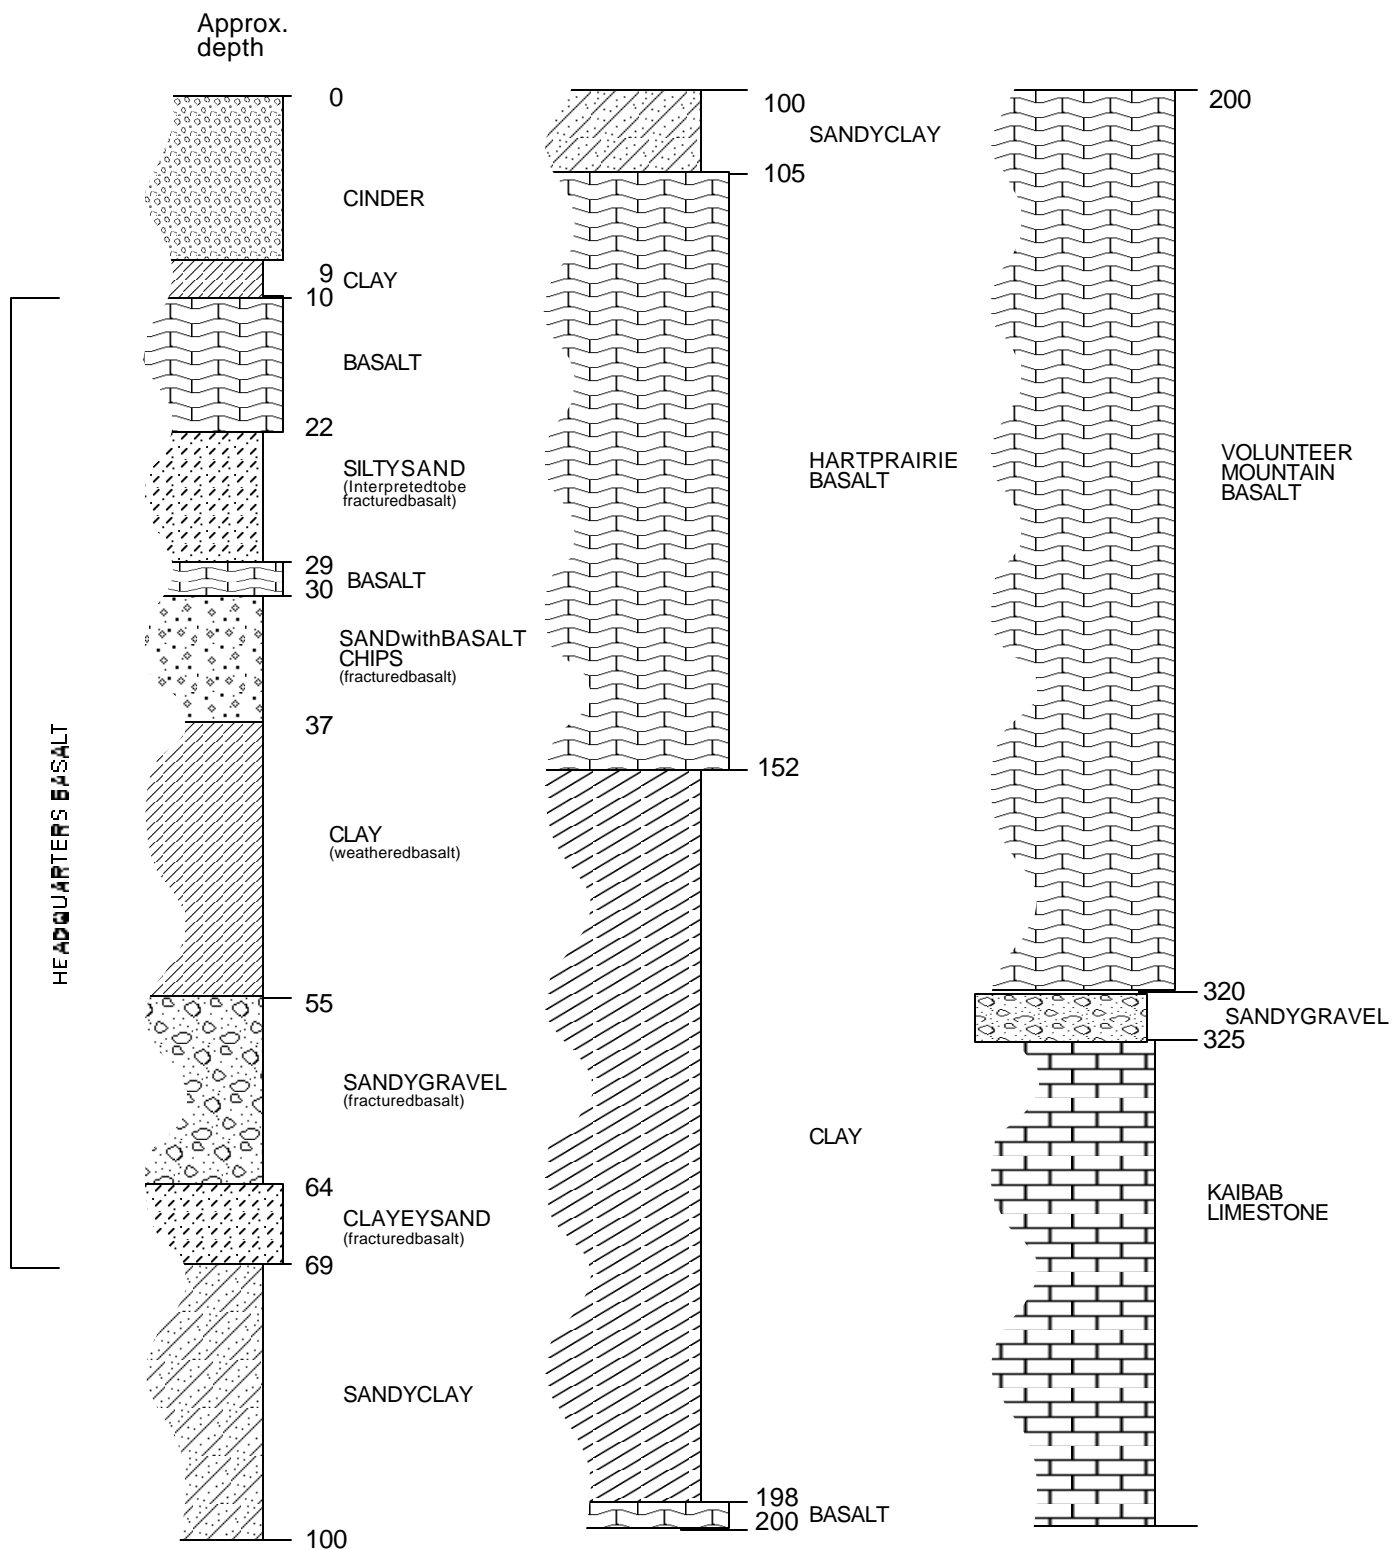
### ***Former Asphalt Plant Stratigraphy***

The following description of the geology of the warehouse area is compiled from surface geologic mapping, and from soil borings in the Warehouse Area, and from geophysical surveys (Figure 3-1) (Tetra Tech 1999a). A monitoring well drilled in 1996 approximately 500 feet east of the site encountered a thin veneer (<10 feet) of clayey soil overlying a thickness of basalt. This basalt is interpreted to be the Headquarters Basalt which underlies the entire Warehouse Area as well as the adjacent Administration Area. The flow is estimated to be about 60 feet thick and overlies a thickness (<35 feet) of Camp Navajo Clay. The Camp Navajo Clay was deposited directly on top of a second basalt flow. This second basalt flow is interpreted to be the Hart Pairie basalt and is 45 feet thick. Below the second basalt is a second clay (45 feet thick) and a third basalt. The third basalt is interpreted to be the Volunteer Mountain basalt and is 120 feet thick. Below the third basalt is a thin zone of gravel and weathered Kaibab Formation (<20 feet) and the underlying Kaibab Formation.
